FEASIBILITY STUDY OF LANDSLIDE RISK ASSESSMENT AND MANAGEMENT

A Case Study of Kolti VDC, Bajura

Group of Helping Hands (SAHAS) Nepal

2015

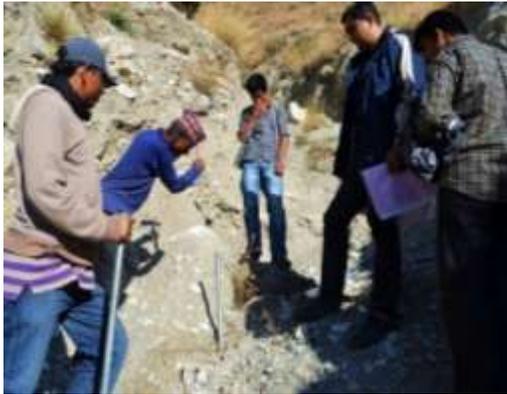
Penetration test was conducted to assess the indication of relative density of existing ground which helps to have a basic understanding of the existing ground. This test is a simple and inexpensive method that includes penetration of metal pipe on the different locations using blows of sledge hammer. Ductile iron pipe of 35mm diameter was penetrated with hammer blows weighing 5kg in different locations of landslide and erosion zone. Number of hammer blows, penetration depth, GPS locations, soil type, slope stability etc. was recorded in different locations of study area ranging from crown of the erosion to the toe deposits. Further, close observation of erosion was done for geological parameters and soil/rock samples were collected from test locations.

Photo 3: Conducting Penetration test

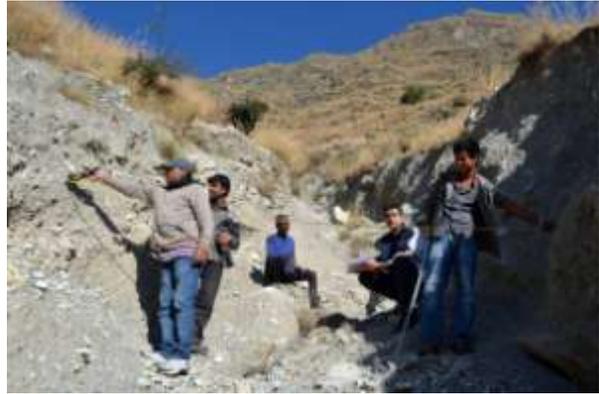
Photo 4: Measuring the width of the Gully erosion

Short intensive rainstorm which occurred throughout the different years form rills and gullies of approximate width up to 15 meters and depth up to 8 meters. The mass movement occurs through formation of branch and tributary gullies that merge into main gully channel causing rapid debris flow. Gully Erosion problem grows as interconnecting systems of gullies spread across the old land surface of different slopes. The resulting run-off from the hillsides brings debris into the settlement areas threatening the villagers and causing major damages.

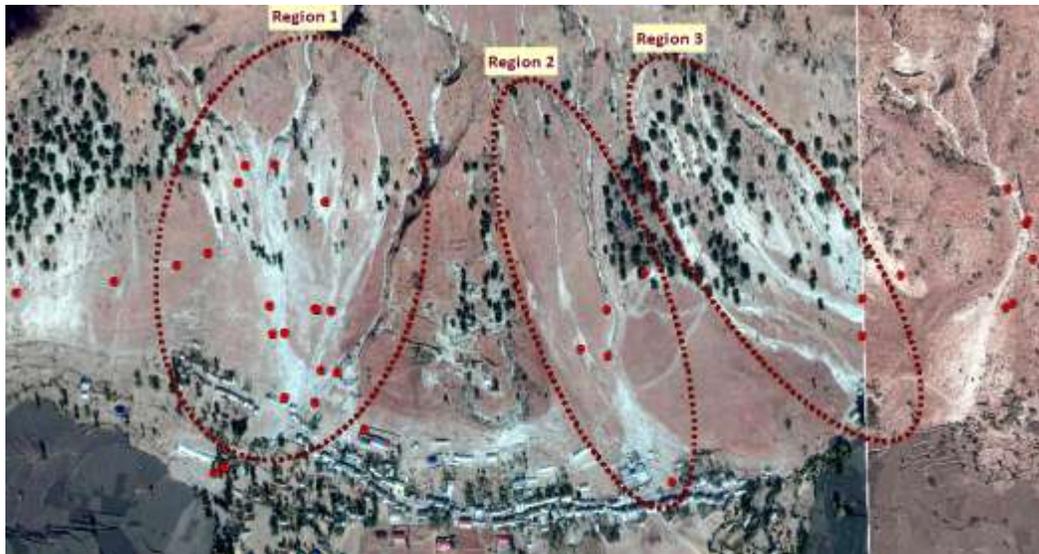
Map 3. Three major erosion zones above Kolti market and airport area with GPS locations of test site

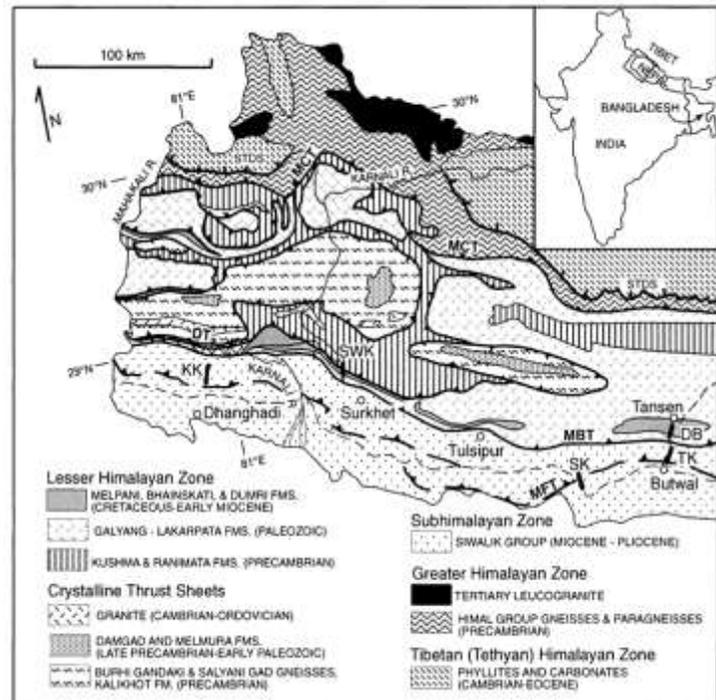
Geologically Kolti VDC lies in Galyang and Ranimata Formation (fig) which consists of dolomitic with in the slate along with phyllitic quartzites metasandstone.

Map 4. Geology of Kolti VDC

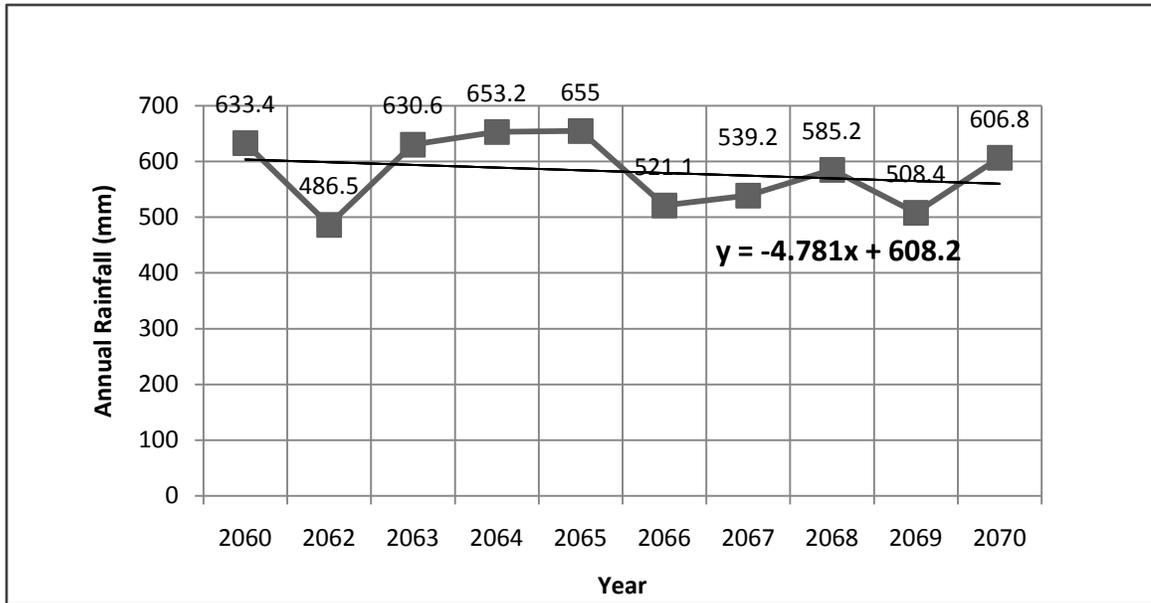
Due to data of short period, it is difficult to show the trendline, although the annual rainfall trend shows in decreasing order from decadal rainfall analysis. Rainfall in 2061 BS (2003) is unusual that deviates all the data. Even excluding the rainfall data of 2061 BS, the trend is negative by -4.8 mm per year. There is no consistency in monthly rainfall also. However, on overage Shrawan (July-Aug) has the highest rainfall of 191 mm and Kartik (October-November) has the lowest of 4.5mm.

Figure 1: Annual Rainfall trend of Kolti Area

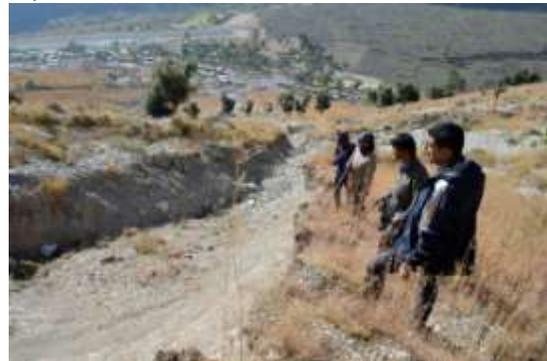
Photo 21: Inspecting the gully erosion by Experts

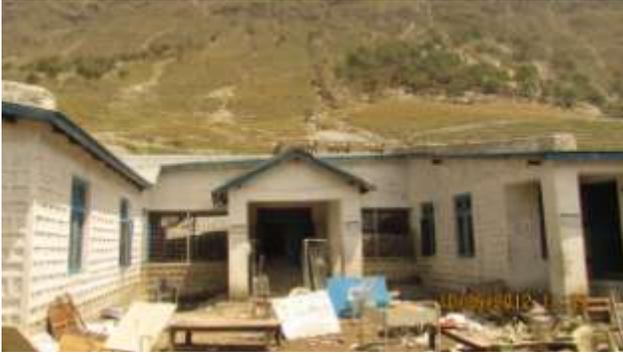
Photo 26: Damaged Hospital

The past landslide (about 200 years ago) buried whole village and new settlements were developed on deposited materials. On 18th Jestha 2069 (31st May 2012) night (in-between 8-9 PM), heavy rainfall with hailstone brought huge mass of debris and buried and washed away 57 houses and shops houses in both Bandhu and Kolti VDCs. This disaster killed 5 people and injured many. The debris flow destroyed water supply system, Primary Health Centre at Kolti, irrigation canals, 5 km road and agriculture land. The same event occurred on 24th Jestha 2071 (June 2014) that washed out 5 houses and completely destroyed 6 houses. The disaster claimed 3 lives from Kolti Bazar. The event affected more than 70 households and many buildings of Primary Health Centre and Army Barrack. The mass movement has eroded public land especially community forest areas heavily. Similarly, it damaged forest nursery with 12,000 plant seedling.

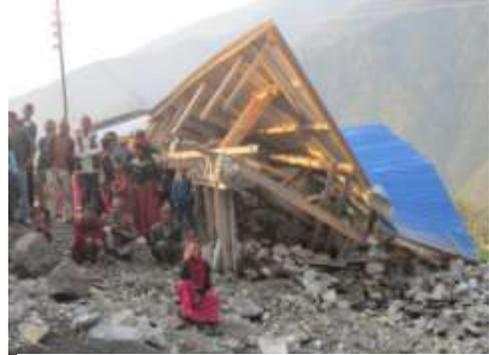
Photo 27: Damaged House

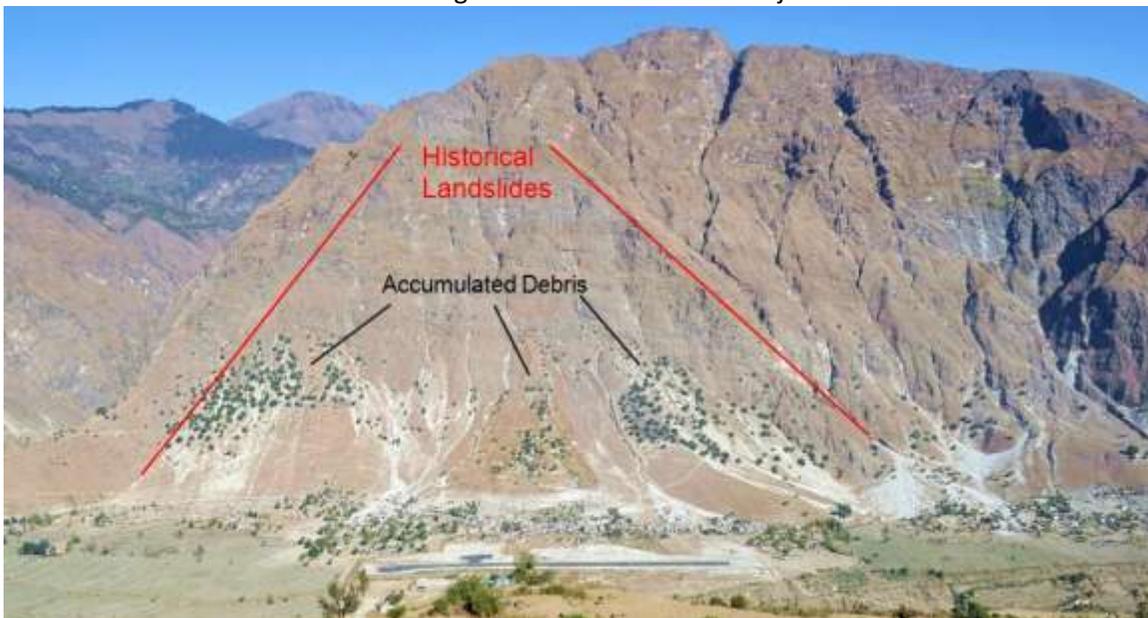
Figure 7: Historical Landslides

The concave nature of the rock indicates a massive landslide as shown in figure 7. The whole area has dolomite dipping against hill slope. The penetration test result shows that the upper part consists of debris deposit up to 2 to 3m then alluvial deposit of nearby river. These deposits is unsettled and mostly composed of granular and weathered rocks with high porosity that makes rainfall to infiltrate at a quicker rate causing massive mass movement. Jure landslide of Sindhupalchok might be the characteristic example of this area; the river terrace covered by the slope failure but detailed geological and geophysical investigation need to be carried out to confirm it. Map 6 shows the Penetration Test Location and the nature of erosion occurred in 2012 and 2014 where a single massive rainfall on accumulated debris triggered large amount of debris flow overwhelming the village and causing major risks to the villagers

The field survey along with interviews with local residents and focused group discussion revealed the historical backdrop of the region. A massive landslide that occurred almost more than 200 years ago had swept the whole village. Later, the village developed itself on the accumulated debris from the slide. According to the local residents, this event was further verified during the construction of Kolti airport in 1984 where buried ancient products such as utensils were discovered. The following has been identified as major causes of erosion:

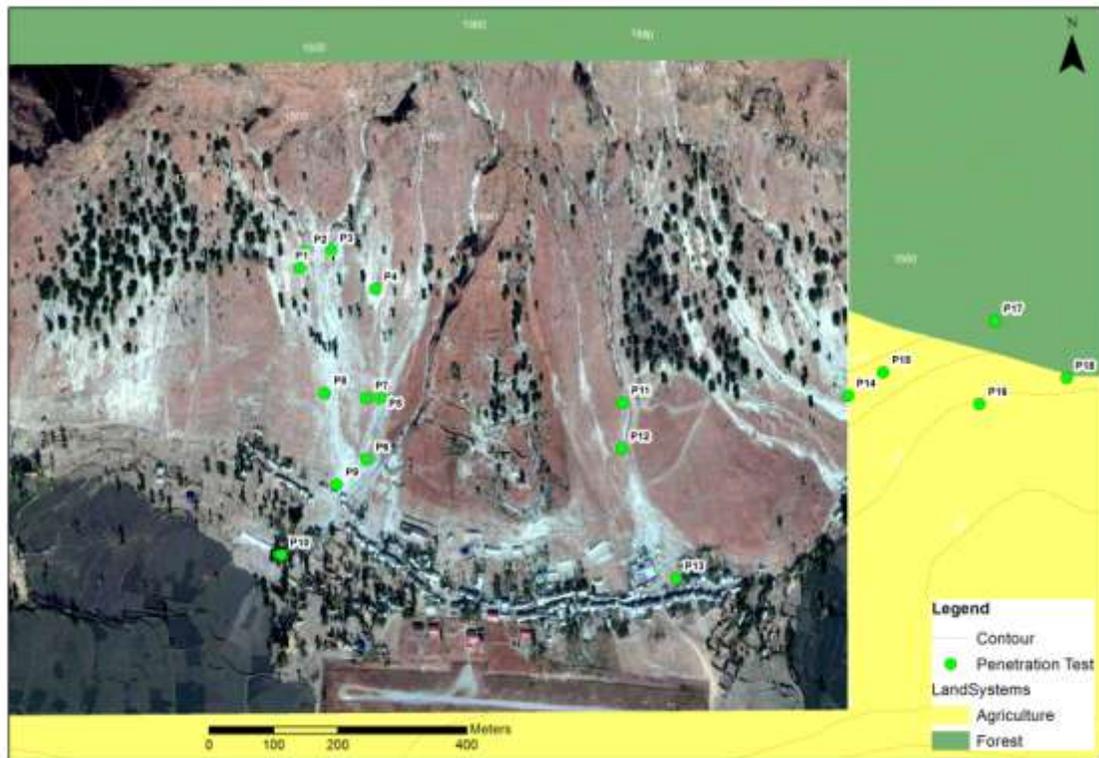
Map 6. Penetration Test Location

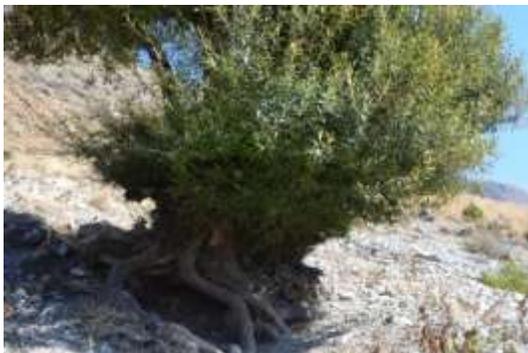
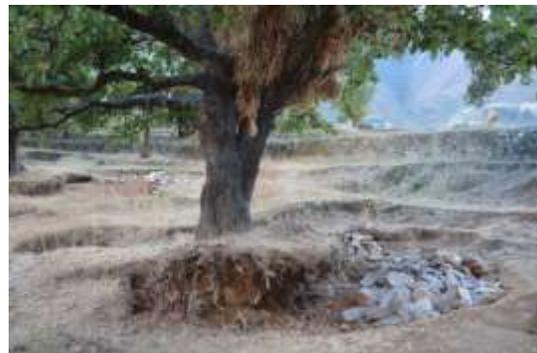
Local residents have been collecting large rock and boulders from the foothill zone of accumulated debris for construction purposes. As observed in the field, currently there are only smaller boulders and weathered rock deposits present. As shown in pictures, large boulders are extracted even from digging the tree roots causing massive damages to soil moisture holding capacity and ultimately causing erosion.

Photo 28: Stone extraction digging beneath the tree root

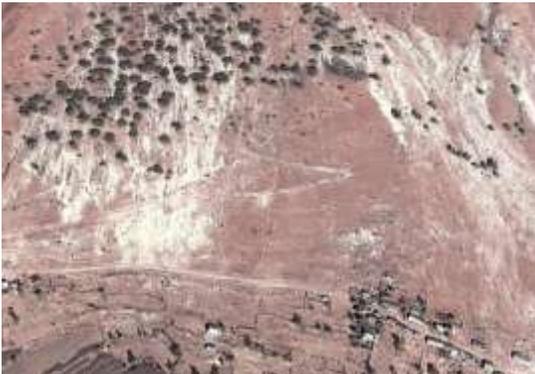
Kolti being one of the major market centers of the region, surrounding VDCs have weaker transportation linkage with it. Construction of road without proper knowledge of soil structure and geology across the disaster prone areas has caused major damages in the vegetation as well as terrain resulting debris flow. As shown in the pictures, the erosion has taken place along the downstream side of road alignment.

Photo 31: Road construction in Bhawanimandu CF

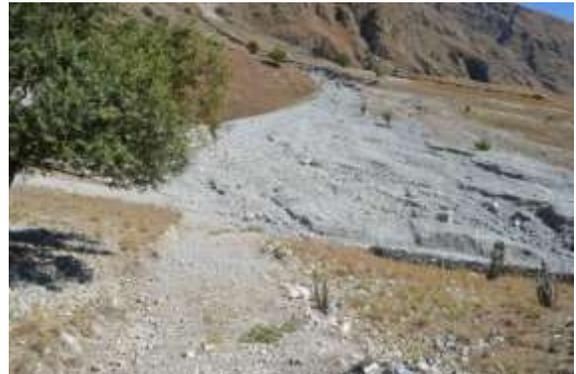
Photo 32: Road construction in Thadomelo CF area

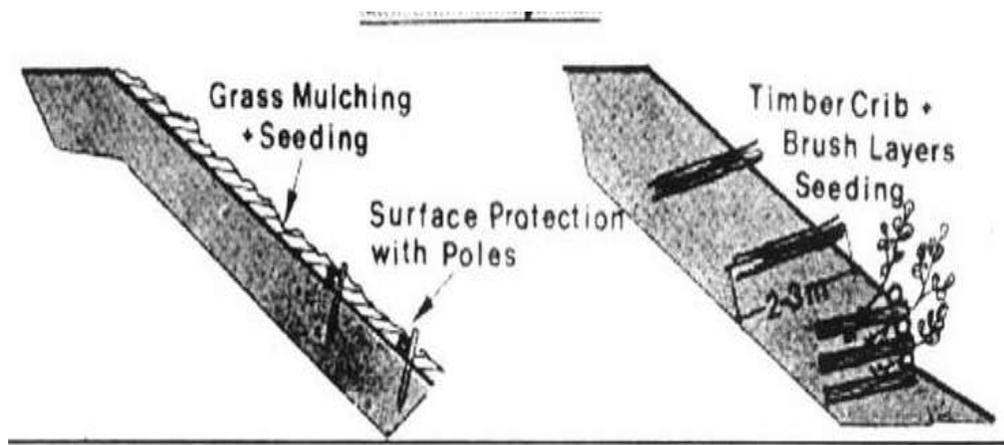
Seeding and Mulching is one of the best solutions after fencing of the area. Locally available plant seeds can be spread across the slope with grass mulching and surface protection with timber cribs and poles. This technology is low cost and can be very affordable with locally available materials.

Figure 8: Examples of seedling and mulching

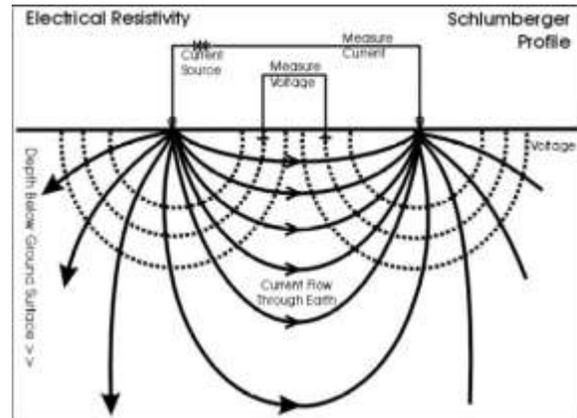
Electrical resistivity survey should be conducted to identify the material properties with respect to different depth. This survey will be particularly helpful in this region to know the exact thickness of the sliding mass. As according to the local residents and field inspection, it was observed that monsoon water directly percolates through the gully and vanishes within the granular material suggesting highly permeable surface with possibility of water sprouts and aquifer directly below the market and airport area. Thus for construction of engineering protective measure, exact knowledge of amount of debris/terrace thickness is required that can be identified with electrical resistivity survey. In this survey, metal probes (electrodes) are inserted into the ground at different spacing and current and voltages are measured to identify the local resistivity of the ground at different depth (Fig 8).

Figure 9: Electrical resistivity

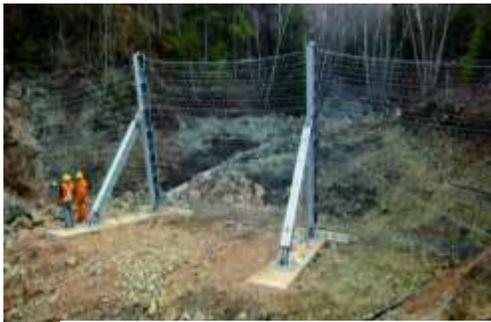
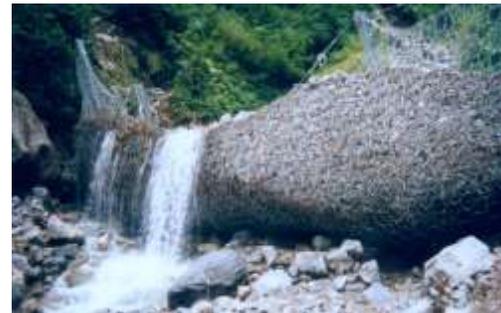
Another option is to install Debris-flow retention nets which can be used for both temporary and permanent protection. This will hold all the debris rolling down gully, which totally minimizes the risk of danger for affected residents. A wire net can be used to trap a debris flow. The advantage of this structure is that it does not require people to work inside a torrent bed. After a debris flow, the debris is removed and the wire net is replaced depending on its damage level. Although some doubts have been raised about its durability, retention nets have been used successfully in Switzerland and Japan.

Photo 36: Examples of debris flow retention nets

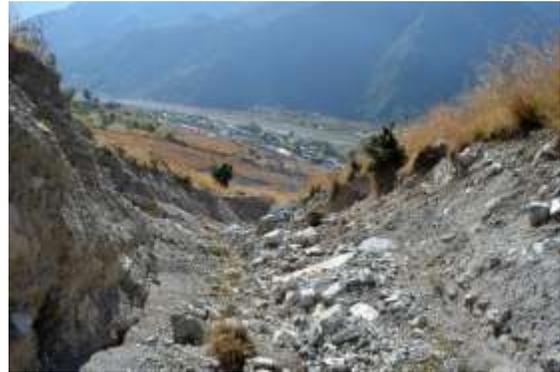
2. Big gully erosion

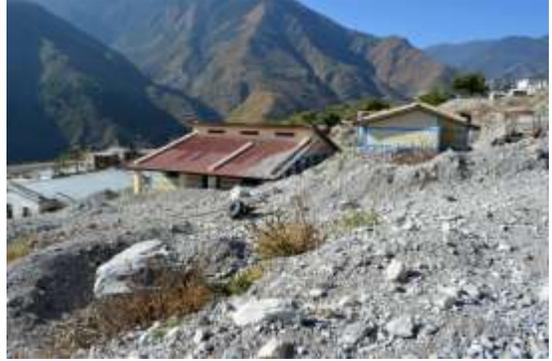
8. Debris materials in health post

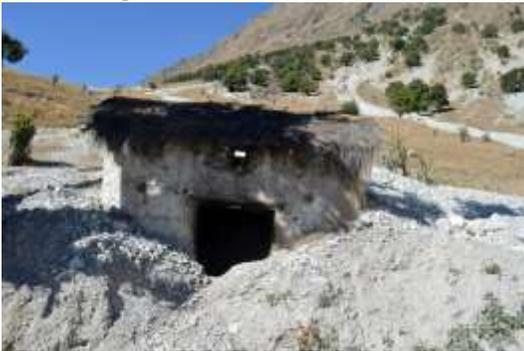
9. House buried after debris flow

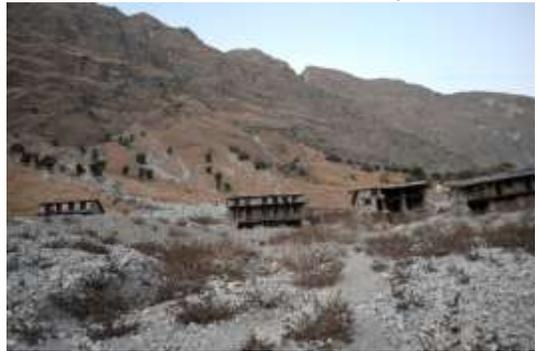
10. More damaged households as a result of debris flow

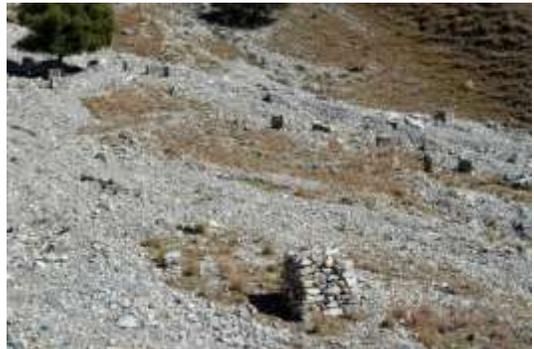
16. Excessive stone collection
